TSAWWASSEN INDIAN RESERVE FLOOD CONTROL WORKS

post-project environmental analysis

D.J.BERNARD and V.G.BARTNIK
MARCH , 1987

Inland Waters and Lands
Pacific and Yukon Region
Vancouver , B.C.

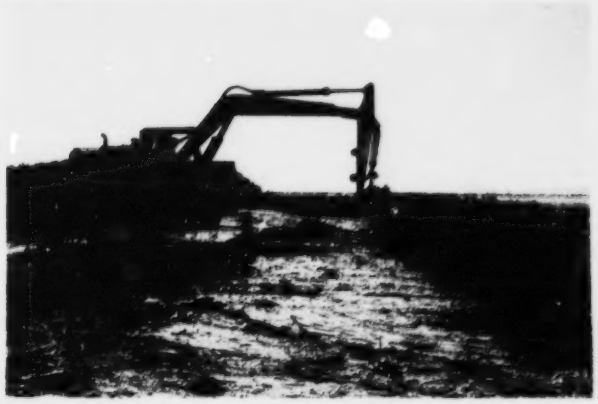
PLATE 1 8 July 1985

Backhoe used alongside the bulldozer for stripping activity to ensure better edging control along the staked toes of the breakwater.

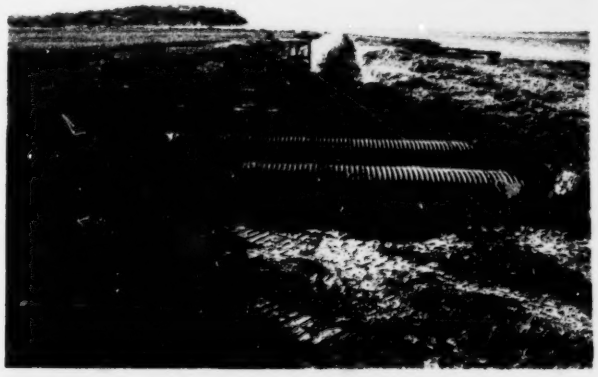
PLATE 9 12 September 1985

During the installation of culverts excavated material was stockpiled on the breakwater for later use in backfilling.

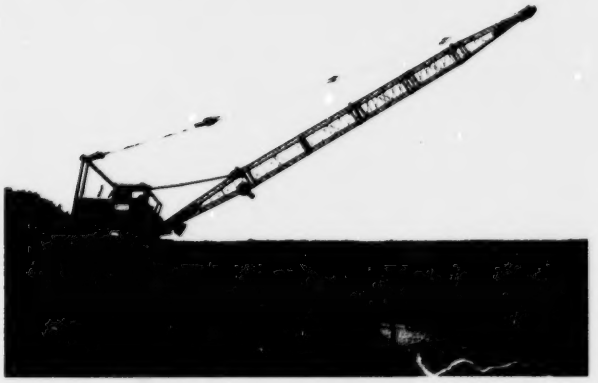
PLATE 14 9 October 1985

The outfall channel was dredged with a dragline operating from moveable pads on the channel bank, thus protecting marsh vegetation from damage. Dredged material (soft silt) was moved by the dragline, in a 4 day period, in progressive steps within the channel with final trucking for disposal at an approved disposal site on the Reserve. Release of silt into the main channel was minimized by operating at low-tide only.

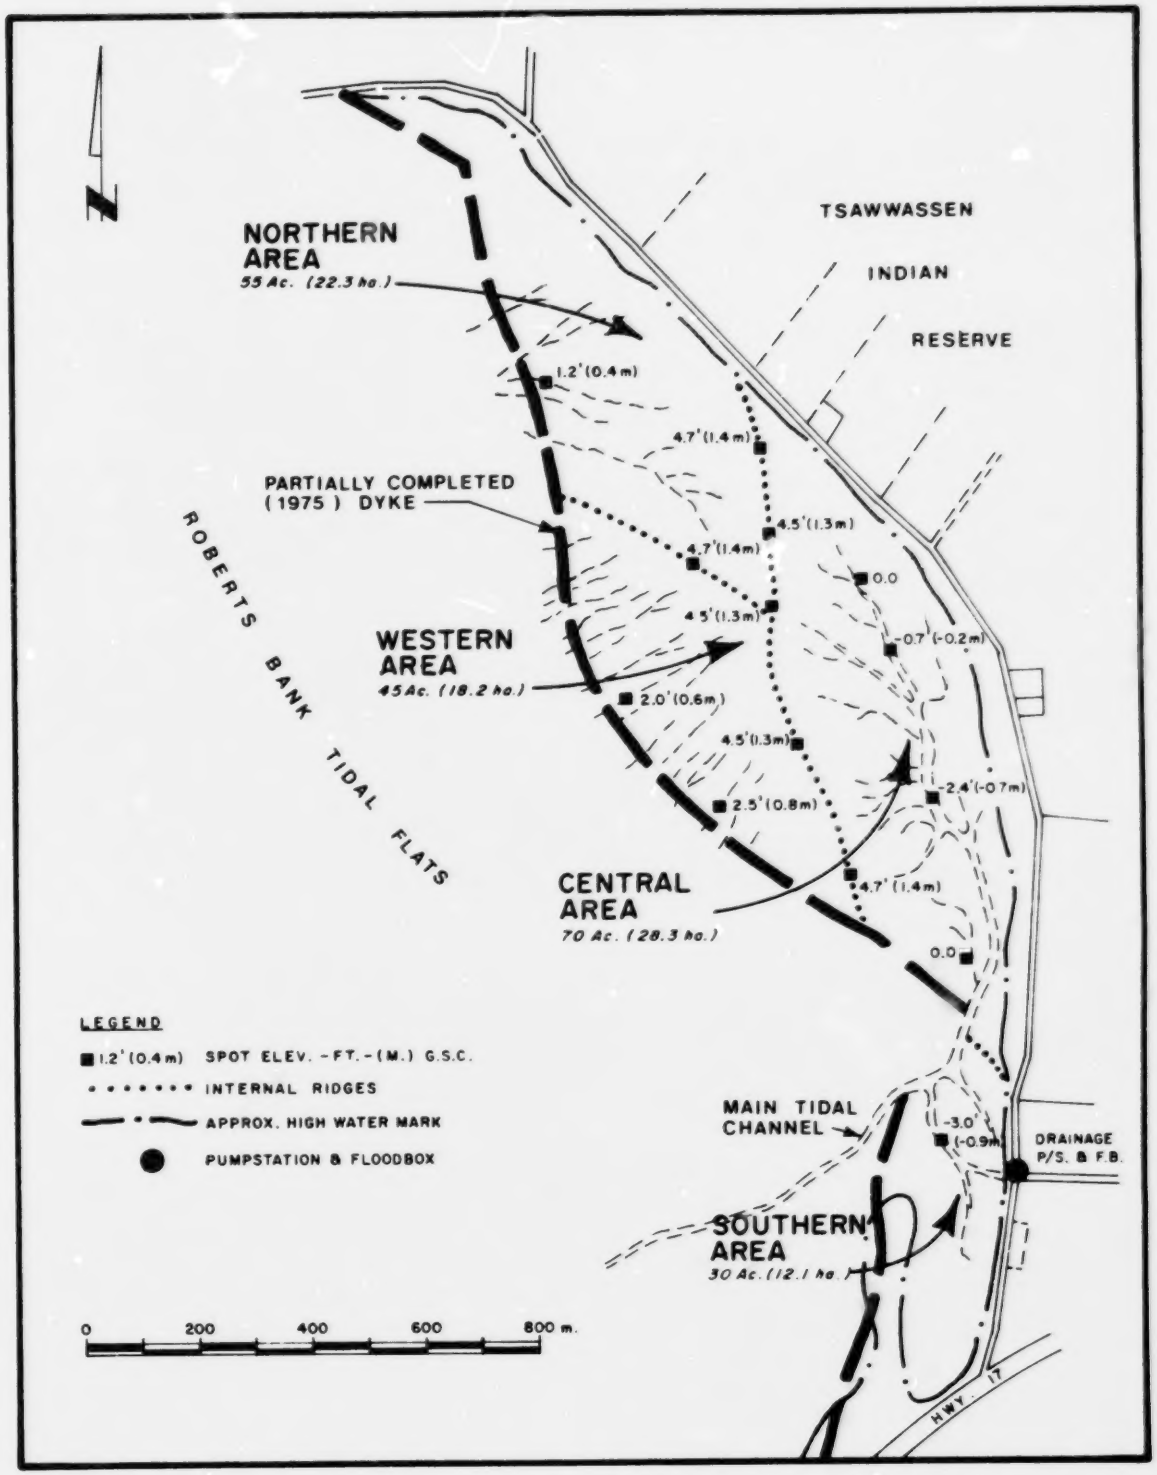
FIGURE 3 THE TSAWWASSEN SALT MARSH DRAINAGE AREAS (adapted from Associated Engineering Ltd. 1984).

The 200-acre (81 ha) accretion between the Roberts Bank and Ferry causeways and west of the Indian Reserve road is commonly known as the Tsawwassen salt marsh. The highest ground in the marsh area is the Tsawwassen Indian Reserve road [elevation 7-8 ft. (2.1-2.4 m) GSC]. The salt marsh has internal ridges [about 4.5 ft. (1.37 m) GSC elevation] which divide the marsh into four drainage areas: northern, western, central and southern which drain through tidal channels onto the adjacent Roberts Bank tidal flats (see Figure 3). At tidal elevations greater than 4.5 ft. (1.37 m) GSC an overflow occurs across these internal ridges.

As a result of construction of the 1975 partially completed dyke, with an average elevation of approximately 7.0 ft. (2.13 m) GSC, tidal blocks had resulted. The northern area was isolated from inundation except when tides exceeded 4.5 ft. (1.37 m) GSC [14.0 ft. (4.27 m) tides] and spill-over from the central area occurred. Similarly a seaward barrier was created across the western area. Most of the dendritic tidal channels were blocked in this area except for two which were reopened, after the 1975 stop-order, to permit some tidal exchange. The main tidal channel carrying seawater into the central and southern areas was untouched by the previous (1975) dyking.

Past studies describing the vegetation of the salt marsh were carried out by Hillaby and Barrett (1976) and Olmsted and Fink (1982). Vegetation mapping by Moody (1986) detected successional change toward more terrestrial communities in the northern and western sectors since 1975, as a result of limited wetting of the salt marsh in these areas.

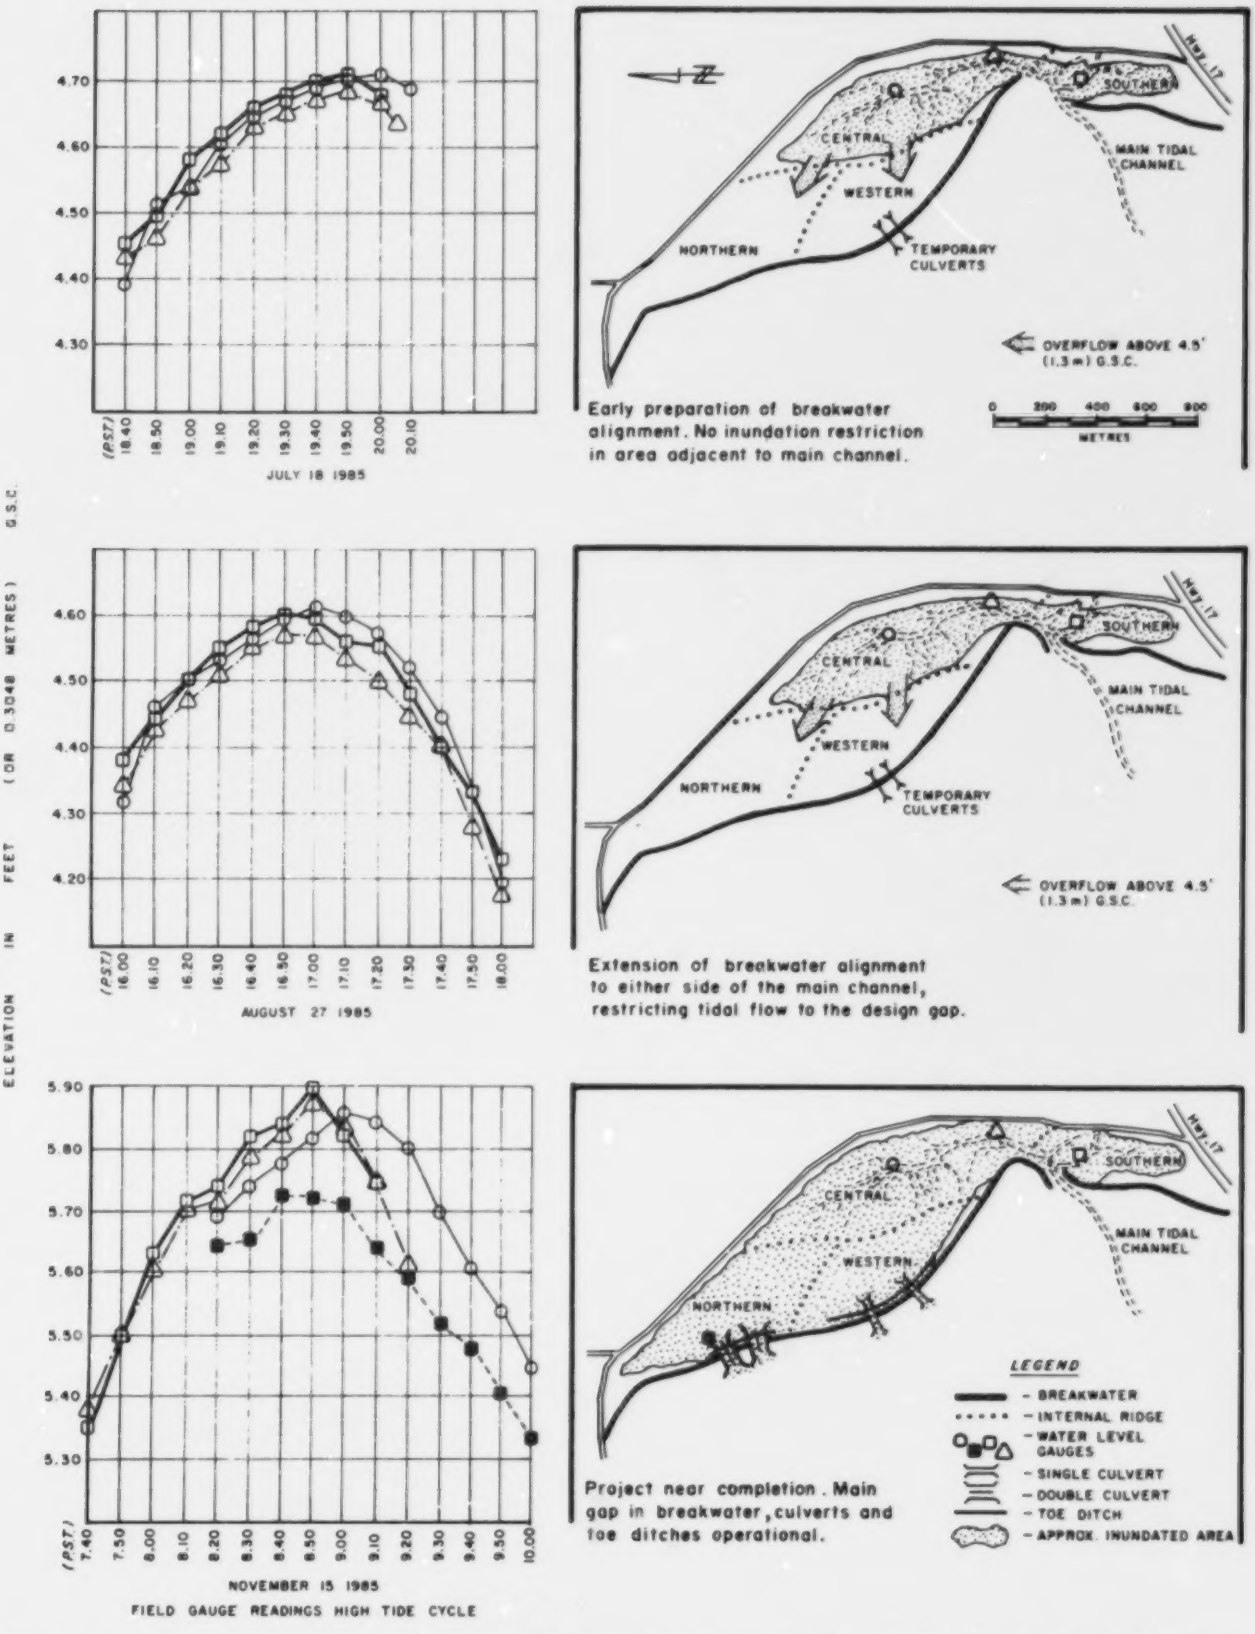
FIGURE 4 HIGH TIDAL CYCLE WATER LEVEL READINGS FROM MONITORED GAUGES (on the left) AND THE CORRESPONDING INUNDATION OCCURRING (on the right) AT THREE DIFFERENT STAGES OF PROJECT CONSTRUCTION (adapted from Associated Engineering Ltd. 1984 and 1986).

Water level gauges set at geodetic datum (Plate 20) were installed at internal channels of the southern, central and northern drainage areas as shown in Figure 4. These gauges were read simultaneously at 10 minute intervals during the rise and fall of a high tidal cycle. The readings were taken on July 18, August 27 and November 15, 1985 when high tides were predicted to reach or exceed 4.5 ft. (1.37 m) GSC. These monitoring dates also corresponded to three different stages of completion of the breakwater/gap/culvert/toe ditch system. The results of the water level monitoring along with the corresponding marsh inundations are shown in Figure 4.

At all three different stages of construction negligible differences in water levels were recorded in the southern and central areas of the marsh. In particular, no discernible differences in water levels occurred after tidal flows in the area of the main channel were restricted to the design gap (compare July 18 and August 27 water levels in Figure 4). On all three monitoring dates the observed tidal peaks in the marsh agreed closely with the recorded tidal gauge station readings at Point Atkinson.

After the culvert/toe ditch system was completed direct tidal access was restored to the northern area but water levels were about 0.1 ft. (3.05 cm) lower than those recorded at other gauges for most of the high tidal cycle (see Figure 4). The difference was almost 0.2 ft. (6.10 cm) lower during the 20-minute peak flooding period. This difference in water level was likely due in part to retardation of the spill-over across the internal ridge by marsh vegetation. In addition, the inverts of the double culverts providing flows to the northern area were at a slightly higher elevation because they had been placed to suit existing marsh tidal channel inverts. Until the culvert/toe ditch drainage system became operational, inundation of the northern area was dependent on overflow across the internal ridge from the central area [at tidal elevation 4.5 ft. (1.37 m) GSC or greater]. The western area similarly depended on overflow from the central area but had some direct tidal access to the foreshore through two small temporary culverts installed during construction. The completion of the culvert/toe ditch system greatly improved the inundation of both of these areas, as shown by the approximate inundation pattern of November 15 (see Figure 4). On that date the high tide was estimated to cover between 66.8 to 70.8 ha of the 81 ha marsh (AEL 1986).

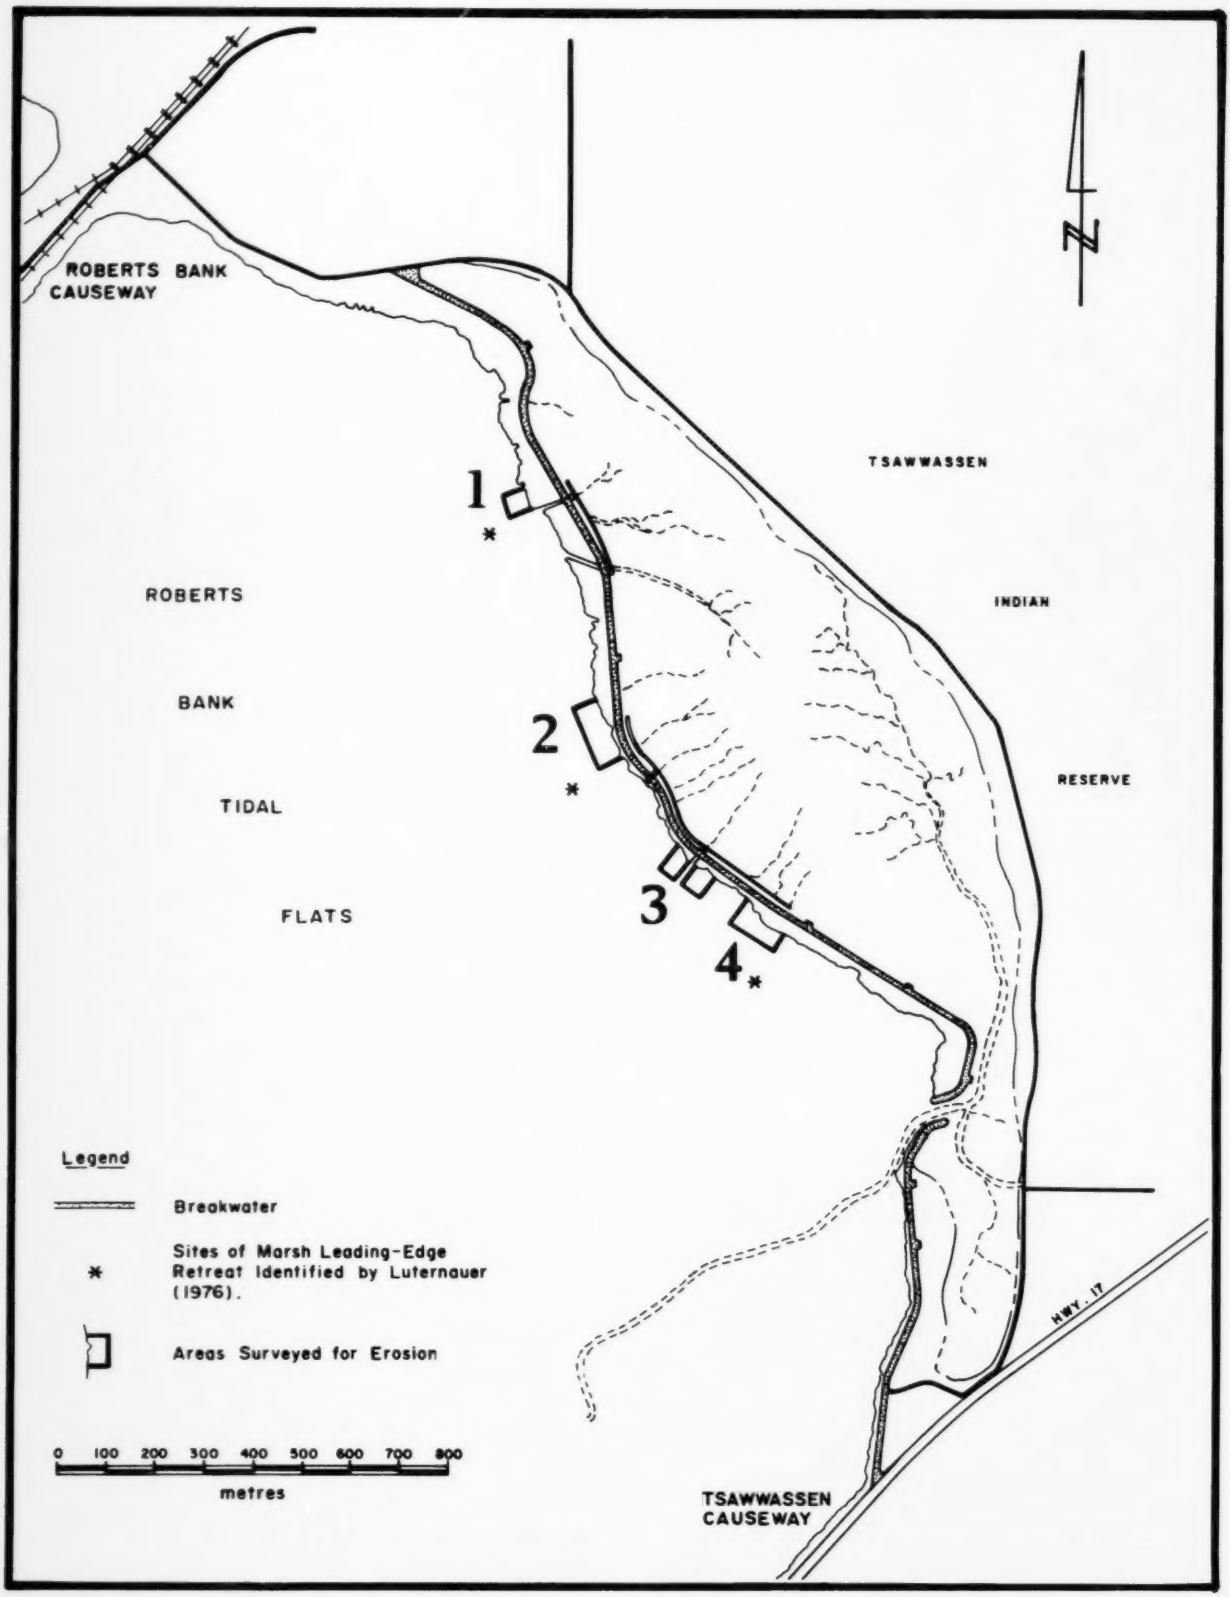
FIGURE 5 AREAS SURVEYED FOR EROSION ALONG THE LEADING-EDGE OF THE MARSH.
